INDOOR AIR QUALITY ASSESSMENT

**Massachusetts Department of Revenue
Fall River Office, Center Place
218 South Main Street
Fall River, Massachusetts**

Prepared by:
Massachusetts Department of Public Health
Center for Environmental Health
Emergency Response/Indoor Air Quality Program
January 2007

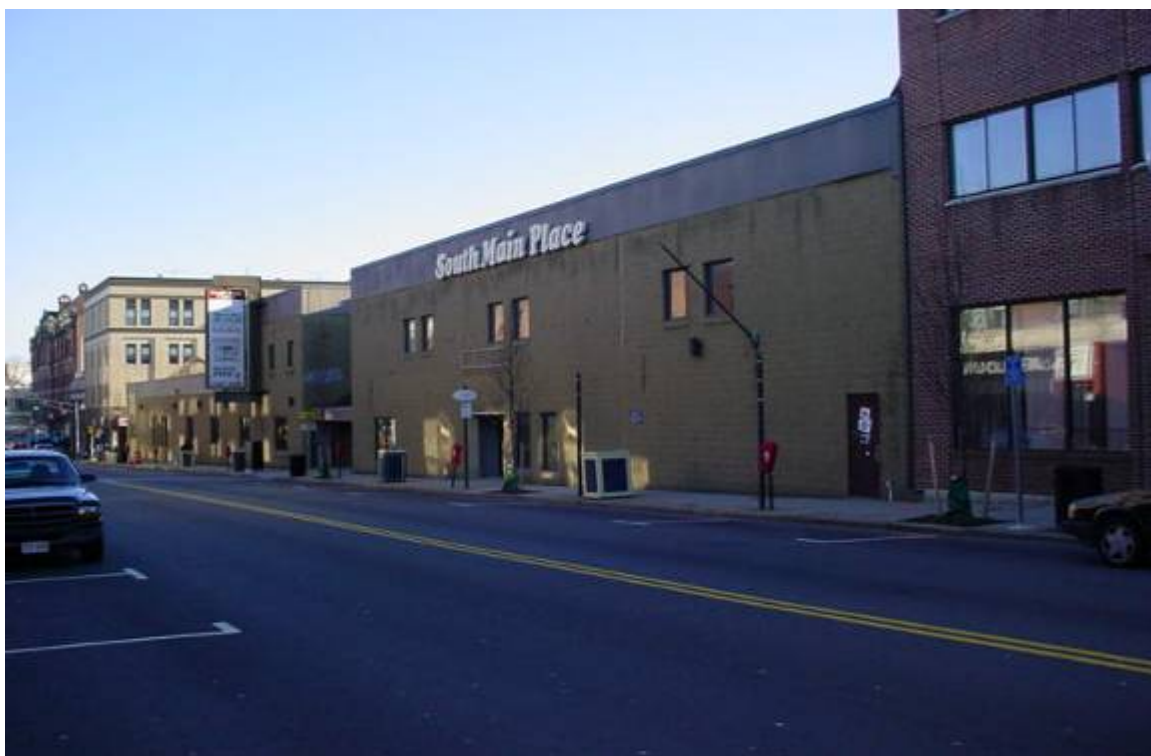
Picture 1

The SMPM was constructed in the 1970s (Picture 1) and is scheduled for demolition as part of the Fall River District Court construction project. Asbestos tile abatement at the SMPM was reportedly completed on Wednesday, January 3, 2007. According to Mr. Trudell, the DOR office was closed on Friday January 5, 2007 and Monday, January 8, 2007 due to an unidentified chemical odor that was attributed to the SMPM demolition work.

The South Main Place Mall (SMPM)

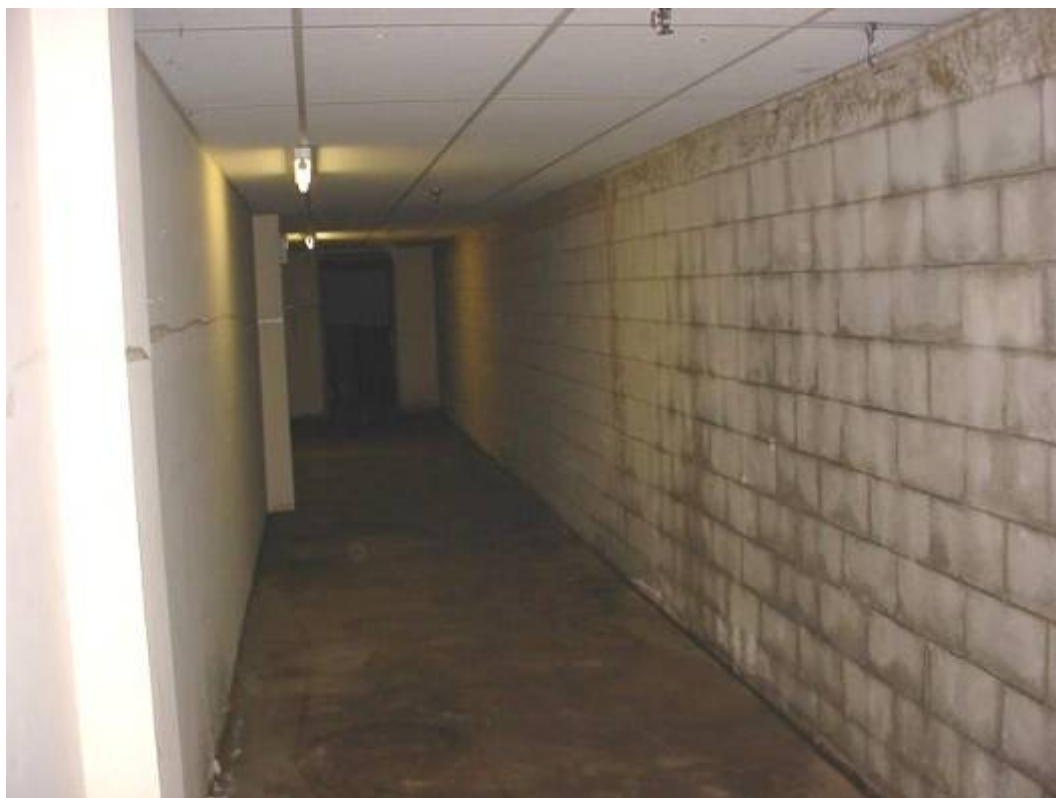
Picture 2

CEH staff examined the SMPM area where the tiles were removed on January 3, 2007. The area is located in an unventilated hallway that runs the length of the wall shared with the DOR office. This area has no means for either mechanical or natural ventilation (Picture 2). TVOC levels measured in this hallway on January 8, 2007 were 4.2 ppm. The product used in the tile removal process is reportedly Chemsafe 100 (Aramco, 2006; [Appendix B](#)), a product containing a hydrocarbon mixture (CAS. No. 64742-88-7, Stoddard solvent IIc) and ethylene glycol monobutyl ether (CAS No. 111-76-2), both of which are volatile organic compounds. The OSHA permissible exposure limit (PEL) for a Stoddard solvent (roughly equivalent to

SMPM Hallway Where Tiles Were Removed

1. Use exhaust fans to draw air from the shared wall cavity. To the knowledge of CEH staff, the SMPM contractor shift begins at 6:30AM. It recommended that this fan be activated at the start of the SMPM contractor shift and operate until the end of the DOR work day.
2. Mop the floor of the SMPM hallway where the tile was removed to remove excess residue left from the Chemsafe 100 product.
3. Identify the source of cold air pressurizing the DOR wall cavity. The two likely sources are the expansion joint between the two buildings (Picture 9) and/or a hole through the SMPM exterior wall (Picture 10).

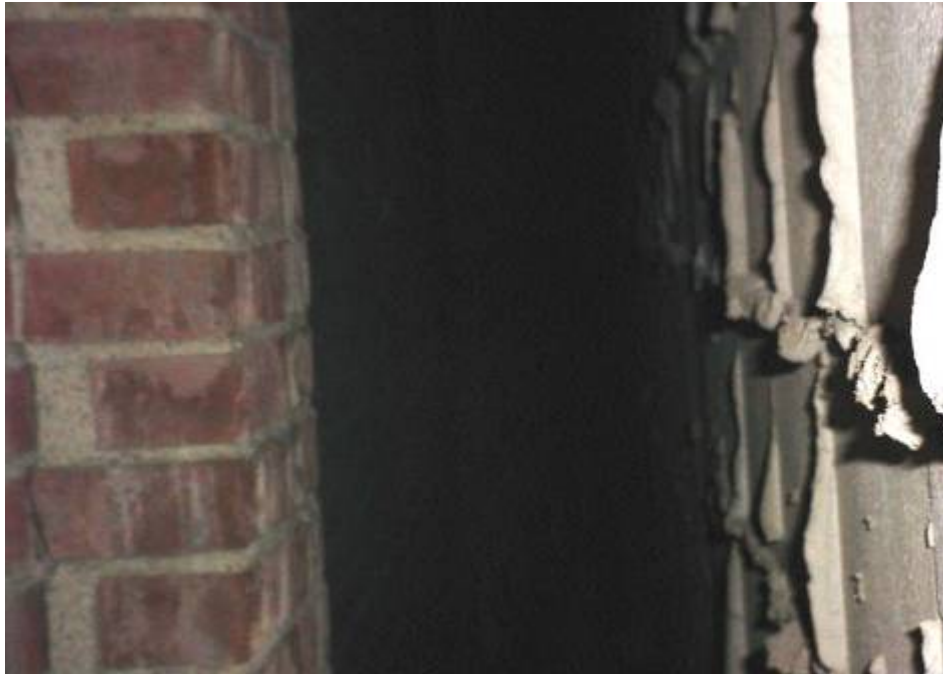
Picture 3

During close examination of the wall between DOR and SMPM, CEH staff discovered that a space approximately 2 feet wide separates the two buildings (Picture 3). Air sampling within the wall space on January 8, 2007, produced a TVOC measurement of 1.5 ppm, indicating that the TVOCs were migrating from hallway where the tile was removed into the wall cavity. Examination of the brick wall on the DOR side of the wall cavity revealed window frames sealed with brick and mortar (Picture 4). Breaches were observed around these window frames. These breaches, the presence of chemical odors in the DOR offices (as reported by DOR staff and Fall River Health Department officials on Friday, January 5, 2007), and measurable levels of VOCs indicate that a pathway for airflow exists in the wall cavity space between the DOR and SMPM.

Wall Cavity Between DOR And SMPM

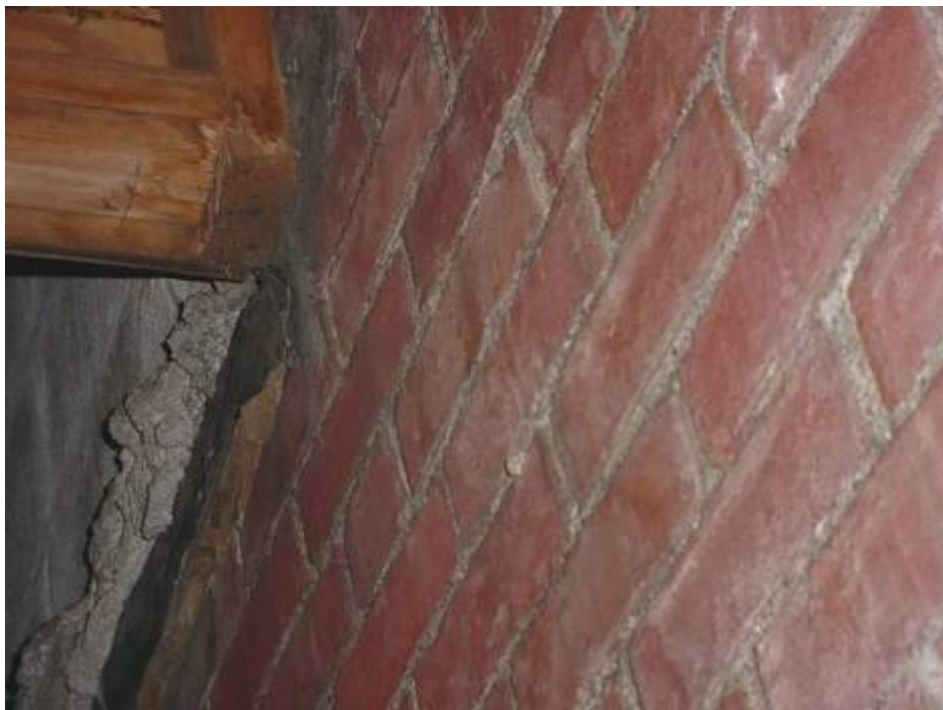
Picture 4

Bricked filled Window Of DOR Building

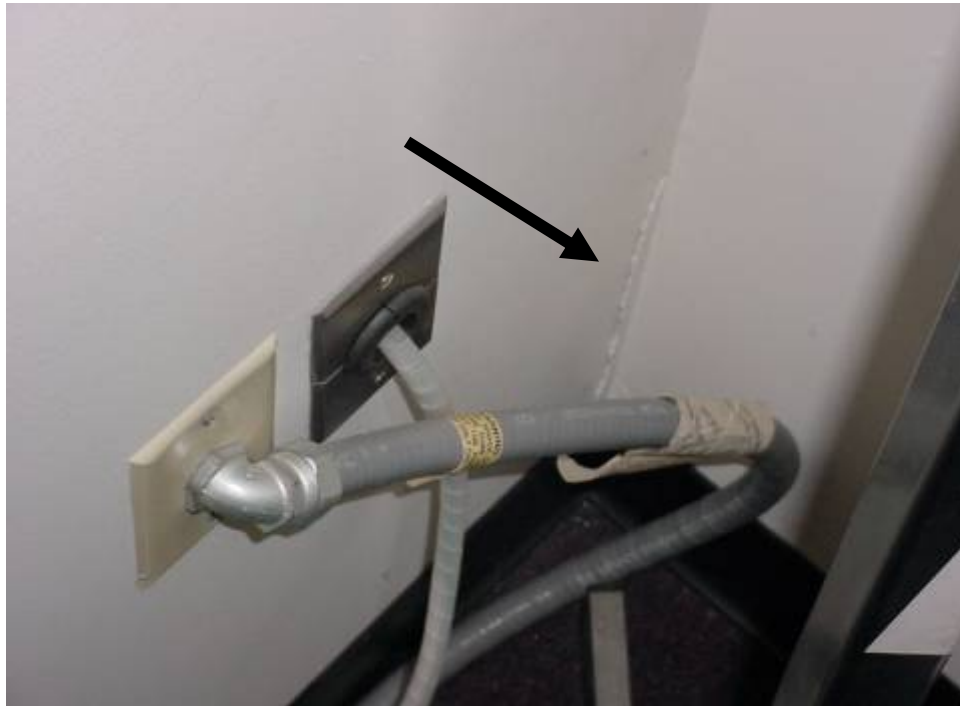
Picture5

A cold draft was detected from a crack in the gypsum wallboard (GW) in the front corner of the DOR first floor office (Picture 5). CEH staff temporarily sealed the crack with duct tape (Picture 6). The cold air infiltrating the DOR office provides additional evidence of a pathway between the two buildings. Cold outdoor air appears to be entering the wall cavity space, which in turn pressurizes this space to force TVOCs into areas occupied by DOR through openings in the GW, such as electrical outlets and seams between the wall coving and carpet.

Crack In GW Of DOR Office, First Floor

4. Seal electrical sockets, cracks in GW, seams in wall coving, the seam between the wall coving and carpet and other means of egress in the affected area, which can serve as pathways for materials to enter occupied spaces from the wall cavity.
5. Use floor fans to pressure the offices along the shared wall with the SMPM.
6. As a safety measure, install a carbon monoxide (CO) detector in the SMPM near the front of the building to detect any build up of products of combustion from gasoline, diesel, propane, acetylene or other flammable materials used for fuel during demolition activities. If the CO alarm activates, cease activities and ventilate the area with exhaust fans.

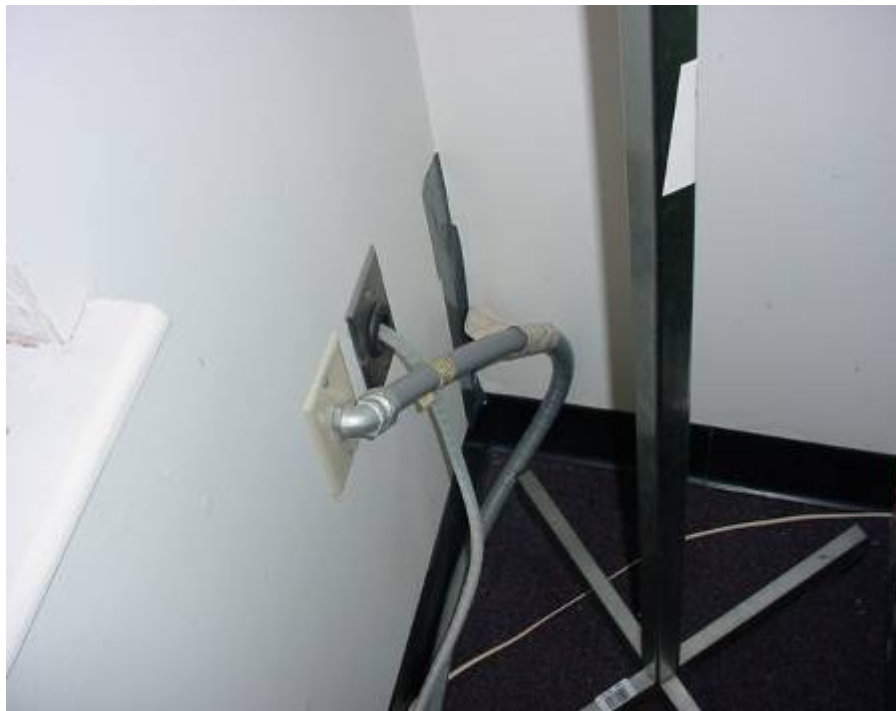
Picture 6

Crack In Picture 4 Sealed With Duct Tape

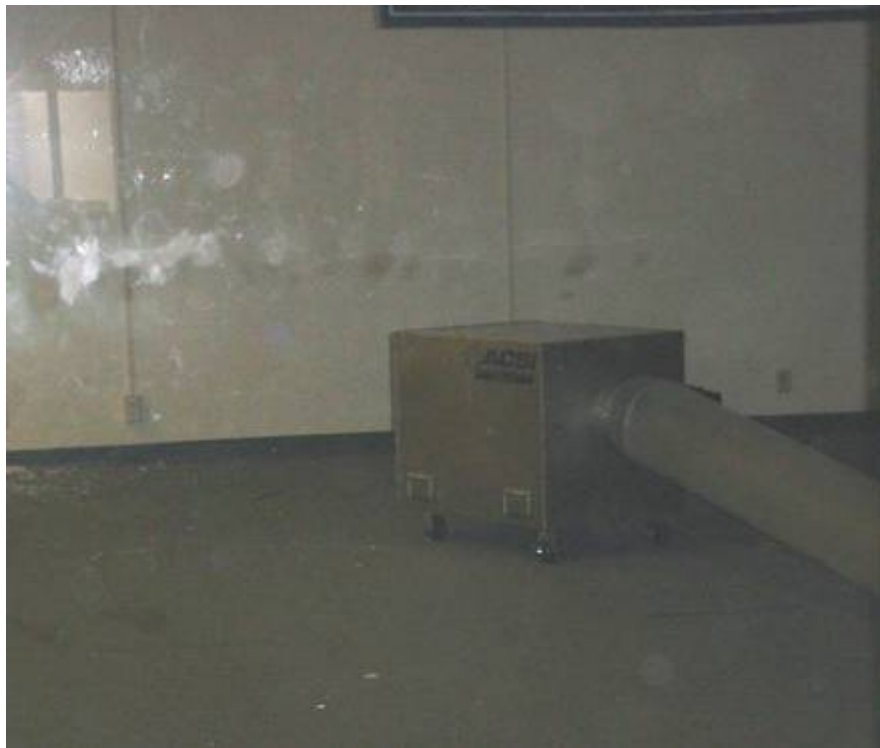
Picture 7

Portable Fan Used To Depressurize Shared Cavity

Based on these observations, CEH staff recommended depressurizing the shared wall cavity with a portable fan (Picture 7). Holes cut in the GW on the SMPM side of the wall were

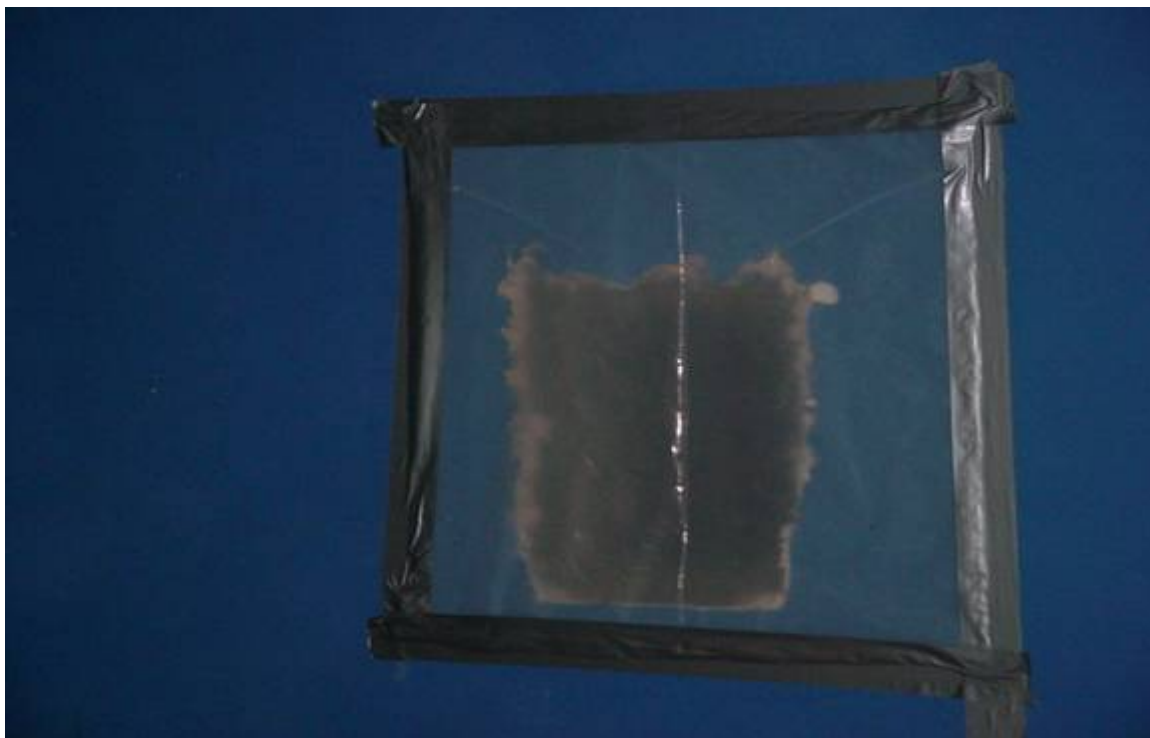
Picture 8

Hole In SMPM GW Sealed With Polyethylene Plastic And Duct Tape To Maximize Wall Space Depressurization

sealed with polyethylene plastic and duct tape (Picture 8) to maximize the draw of air from the wall cavity.

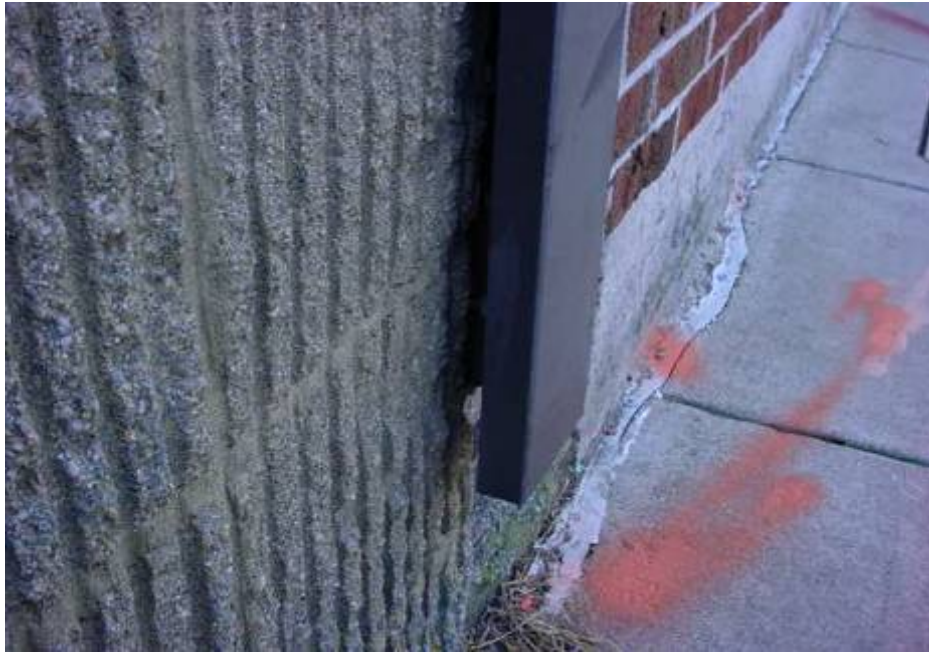
Picture 9

Expansion Joint Between SMPM And DOR Building

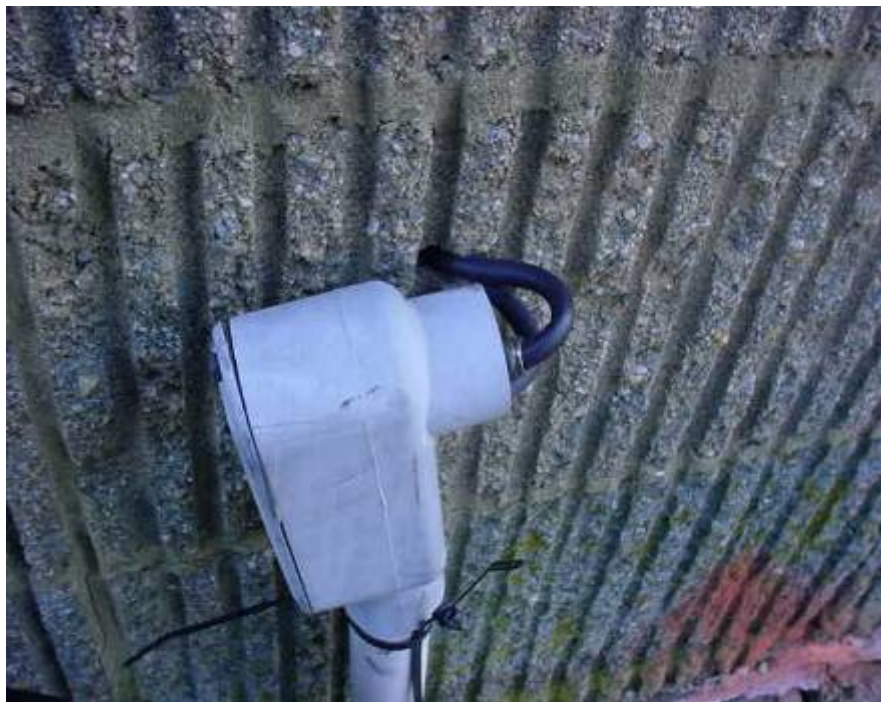
Picture 10

Wall Penetration For Utility In SMPM Wall Near DOR Building
